# Appendix I

# Strategic Flood Risk Assessment

# A.1.1 The context for Tobercurry LAP Flood Risk Assessment

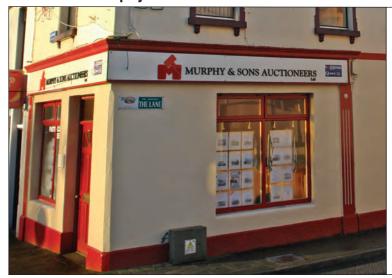
SoN no. 2 - Murphy & Sons Auctioneers at Wolfe Tone Square

#### Valuable features

- smooth render fascia;
- moulded cornice and pilasters;
- painted render plinth;
- fanlight above door;
- chamfered corner at ground floor.

#### **Recommendations:**

- Replace the sign board with hand-painted signage or a sign board which fits into the fascia.
- Replace the timber door with a traditional timber door with no in-built glass panels.

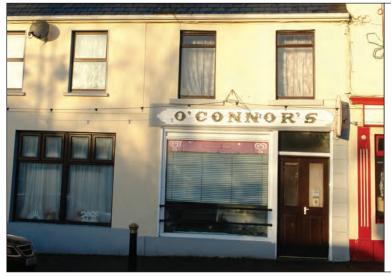
#### Valuable features

- smooth render fascia;
- mosaic lettering;
- window opening;
- bars across window;
- double doors;
- fanlight.

#### **Recommendations:**

Remove adhesive advertising on window and internal blinds. This shop would benefit from being occupied.

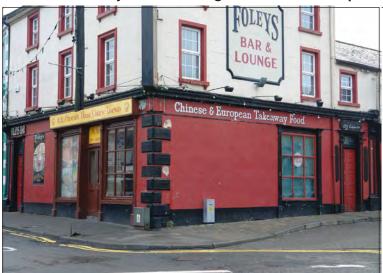
#### SoN no. 4 - Foleys Bar & Lounge at Wolfe Tone Square

#### Valuable features

- corner shopfront;
- moulded cornice, consoles and pilasters;
- timber shopfront and double doors;
- timber architraves surrounding doors on each elevation;
- fanlights above doors;

#### **Recommendations:**

- Any additional signage on this building should be hand-painted.
- Remove the lighting fixtures over the shopfront and the projecting box sign.
- Remove the signage affixed to the northern wall of this building.

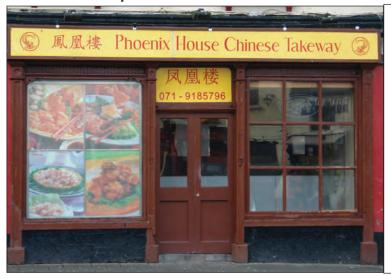
#### **Detail of the shopfront**

#### Valuable features

- timber pilasters;
- joinery details;
- stone plinth;
- timber vents;
- fixtures for original shutters;
- stone cills.

#### **Recommendations:**

- Remove the signage box over this shopfront, the adhesive signage on the window and the signage above the entrance.
- Replace with hand-painted signage on the original fascia.
- Paint the shopfront in a brighter colour to highlight the detailed craftsmanship.

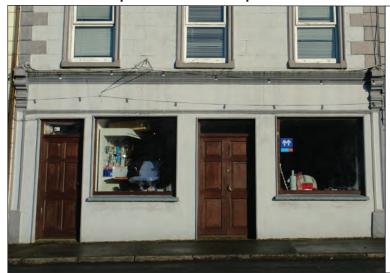
#### SoN no. 5 - Shop at Wolfe Tone Square

#### Valuable features

- smooth render cornice;
- render consoles and pilasters;
- render plinth;
- fanlight above doors;
- window openings;
- double doors.

#### **Recommendations:**

- Any signage on this shop front should be hand-painted.
- Windows to either side of central door should be lowered to their original cill level likely to be to the top of the pilaster plinth.

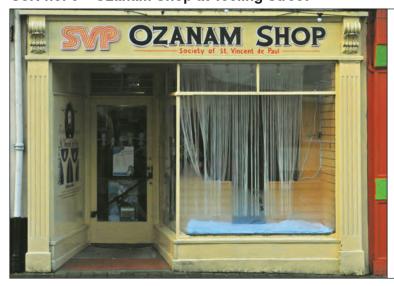
#### SoN no. 6 - Ozanam Shop at Teeling Street

#### Valuable features

- recessed doorway;
- clerestorey window arrangement and joinery to shop window;
- window opening;
- · bars across fanlight;
- window mullions;
- ironmongery to door.

#### **Recommendations:**

- Replace the recently removed historic opaque glass on the clerestorey.
- Replace the modern shopfront with a traditional shopfront.
- Re-tile the entrance lobby appropriately.

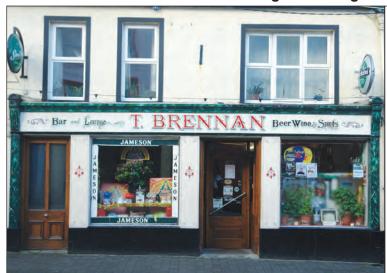
#### SoN no. 7 - T. Brennan's Bar and Lounge at Teeling Street

#### Valuable features

- render pilasters, cornice and consoles;
- fanlight above door;
- window openings;
- hand painted signage;
- timber double external doors;
- ironmongery to internal door.

#### **Recommendations:**

- Remove adhesive advertisements from the windows.
- Replace the recently removed single and double sash windows from the upper floor. These windows are considered integral to the appearance of the shopfront.

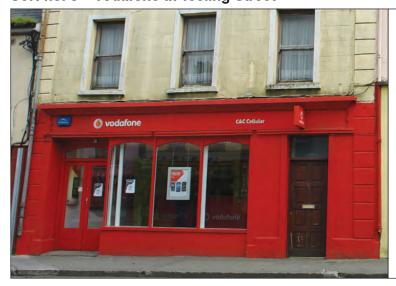
#### SoN no. 8 - Vodafone at Teeling Street

#### Valuable features

- render cornice and fascia;
- double doors;
- cast iron internal columns;
- fanlight.

#### **Recommendations:**

Replace the sign board with hand-painted signage or a signage board which fits into the render fascia.

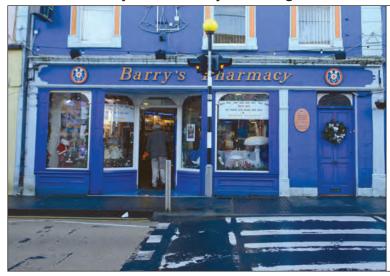
#### SoN no. 9 - Barry's Pharmancy at Teeling Street

#### Valuable features

- smooth render fascia;
- moulded cornice, pilasters and plinth;
- fanlight above doors;
- delicate timber corner fan details to windows;
- double doors.

#### **Recommendations:**

- Remove crude lighting over shopfront.
- Clean rendered cornice above shopfront.

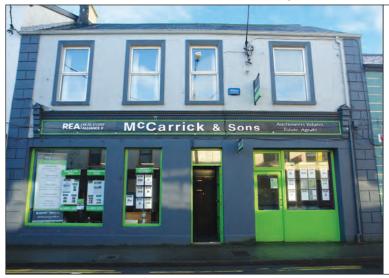
#### SoN no. 10 - McCarrick & Sons at Teeling Street

#### Valuable features

moulded decorative cornice and consoles.

#### **Recommendations:**

■ This shopfront is in good condition. If further enhancements are sought, the configuration and treatment of the window and door openings should be restored in a traditional style.

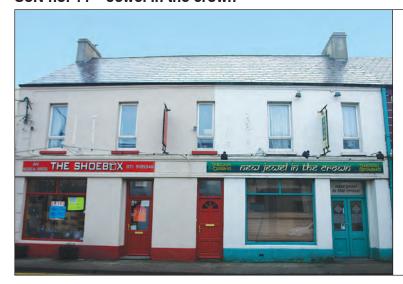
#### SoN no. 11 - Jewel in the crown

#### Valuable features

- moulded cornice frame;
- decorative double doors;
- clerestory window arrangement to main window;
- fanlight above door; render plinth;
- stone hearth at entrance;
- cast iron downpipe.

#### **Recommendations:**

- Remove signage boards and replace with hand-painted signage.
- Projecting signage should be at fascia level and limited to one per building.
- Remove inappropriate lighting fixtures.
- Replace upper floor uPVC windows with timber sliding sash windows.
- Replace non-traditional doors with solid framed door without fake Georgian arch.
