2.6 Applicability of the Factor of Safety (Deterministic) Approach for Peat Slopes

3 DESK STUDY

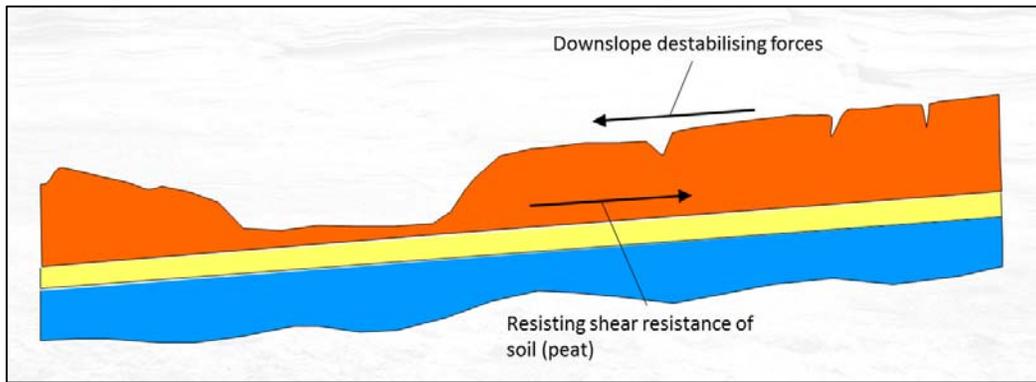
Figure 2-2: Peat Slope Showing Balance of Forces to Maintain Stability

The factor of safety provides a direct measure of the degree of stability of a slope and is the ratio of the shear resistance over the downslope destabilising force. Provided the available shear resistance is greater than the downslope destabilising force then the factor of safety will be greater than 1.0 and the slope will remain stable. If the factor of safety is less than 1.0 the slope is unstable and liable to fail. The acceptable result for factor of safety is 1.3 and above.

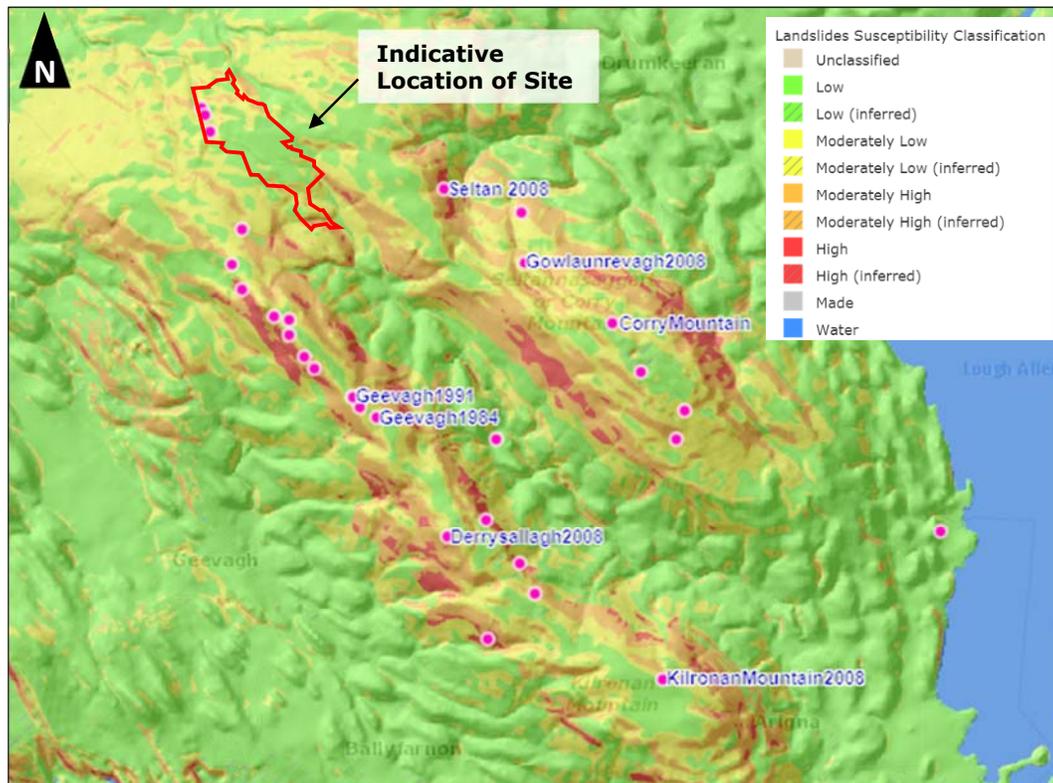
Figure 3-1: Plan showing landslide events and landslide susceptibility (GSI, 2019)

The Lough Allen upland area has a high density of historical landslides (Pellicer, 2006), which are dominantly associated with peat failures from the plateau and surrounding steep slopes outside of the proposed development footprint (Figure 3-1).

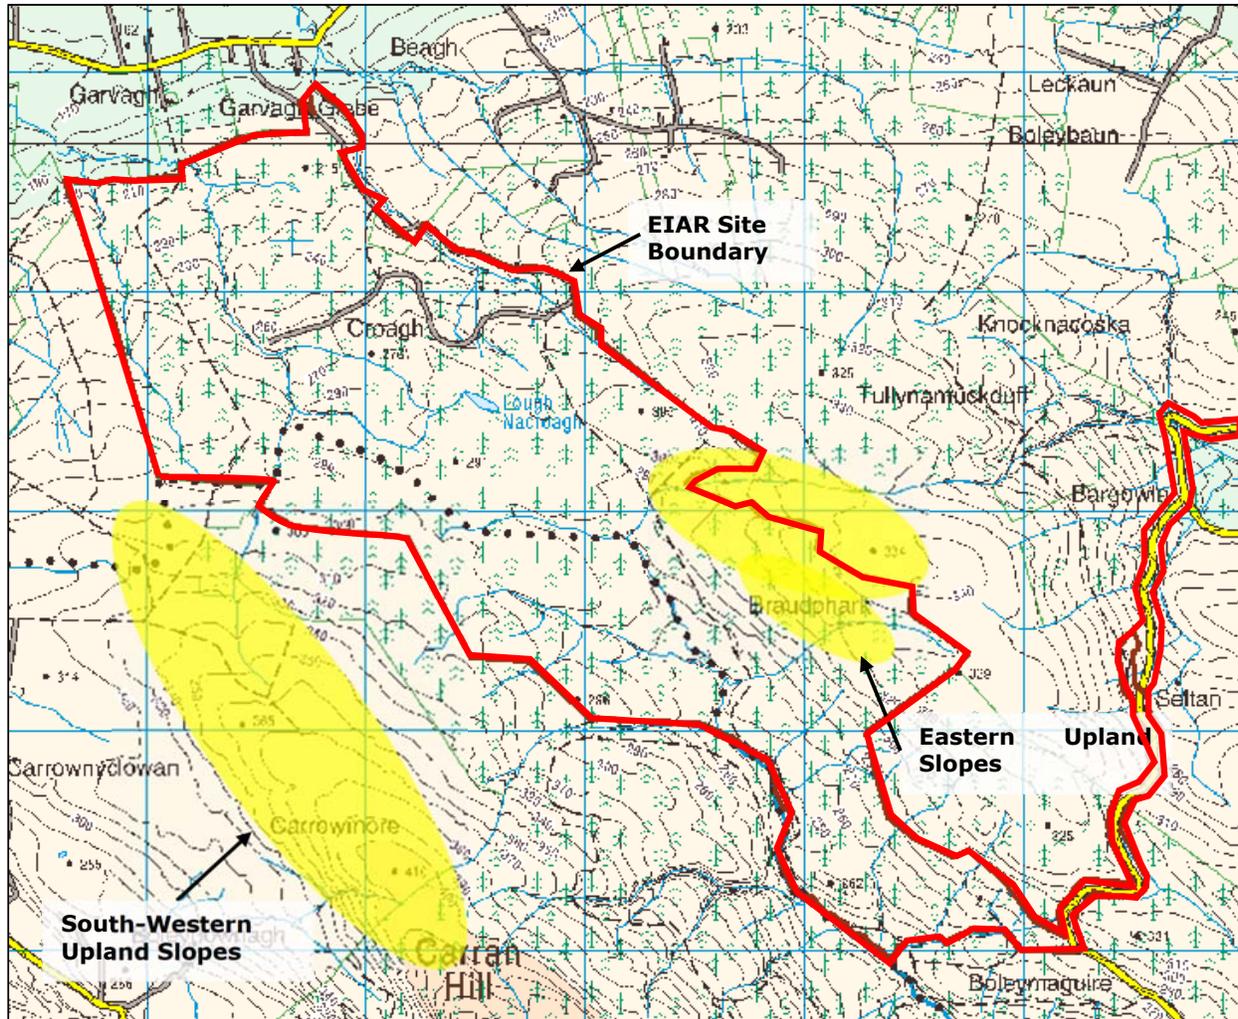
Figure 4-2: Indicative extent of adjacent upland slopes inspected by FT

- (1) The upland slopes to the east of the site boundary are covered in blanket peat with peat depths ranging from 0.9 to in excess of 7.5m with an average of 3.3m. The deeper peat was encountered in the flatter areas with thinner peat on the steeper surrounding slopes.
- (2) Quaking peat was noted at a number of the deeper peat areas. Quaking peat has previously been linked with peat instability/failure however with the presence of the flat terrain in these areas, the risk of peat failure is considered low.

- (3) No significant signs of previous peat instability/failure were noted on the slopes.
- (4) Notwithstanding the significantly deep peat recorded on the eastern slopes, the risk of peat instability/failure in this area is low provided the natural state of the peat slopes remains unchanged i.e. no construction works, change in drainage regime or similar activities take place on the slopes. The low risk in the deeper peat areas is attributed to the flat terrain present.
- (5) Where construction works are proposed within this area, the implementation of appropriate construction measures will maintain a low risk of peat instability.

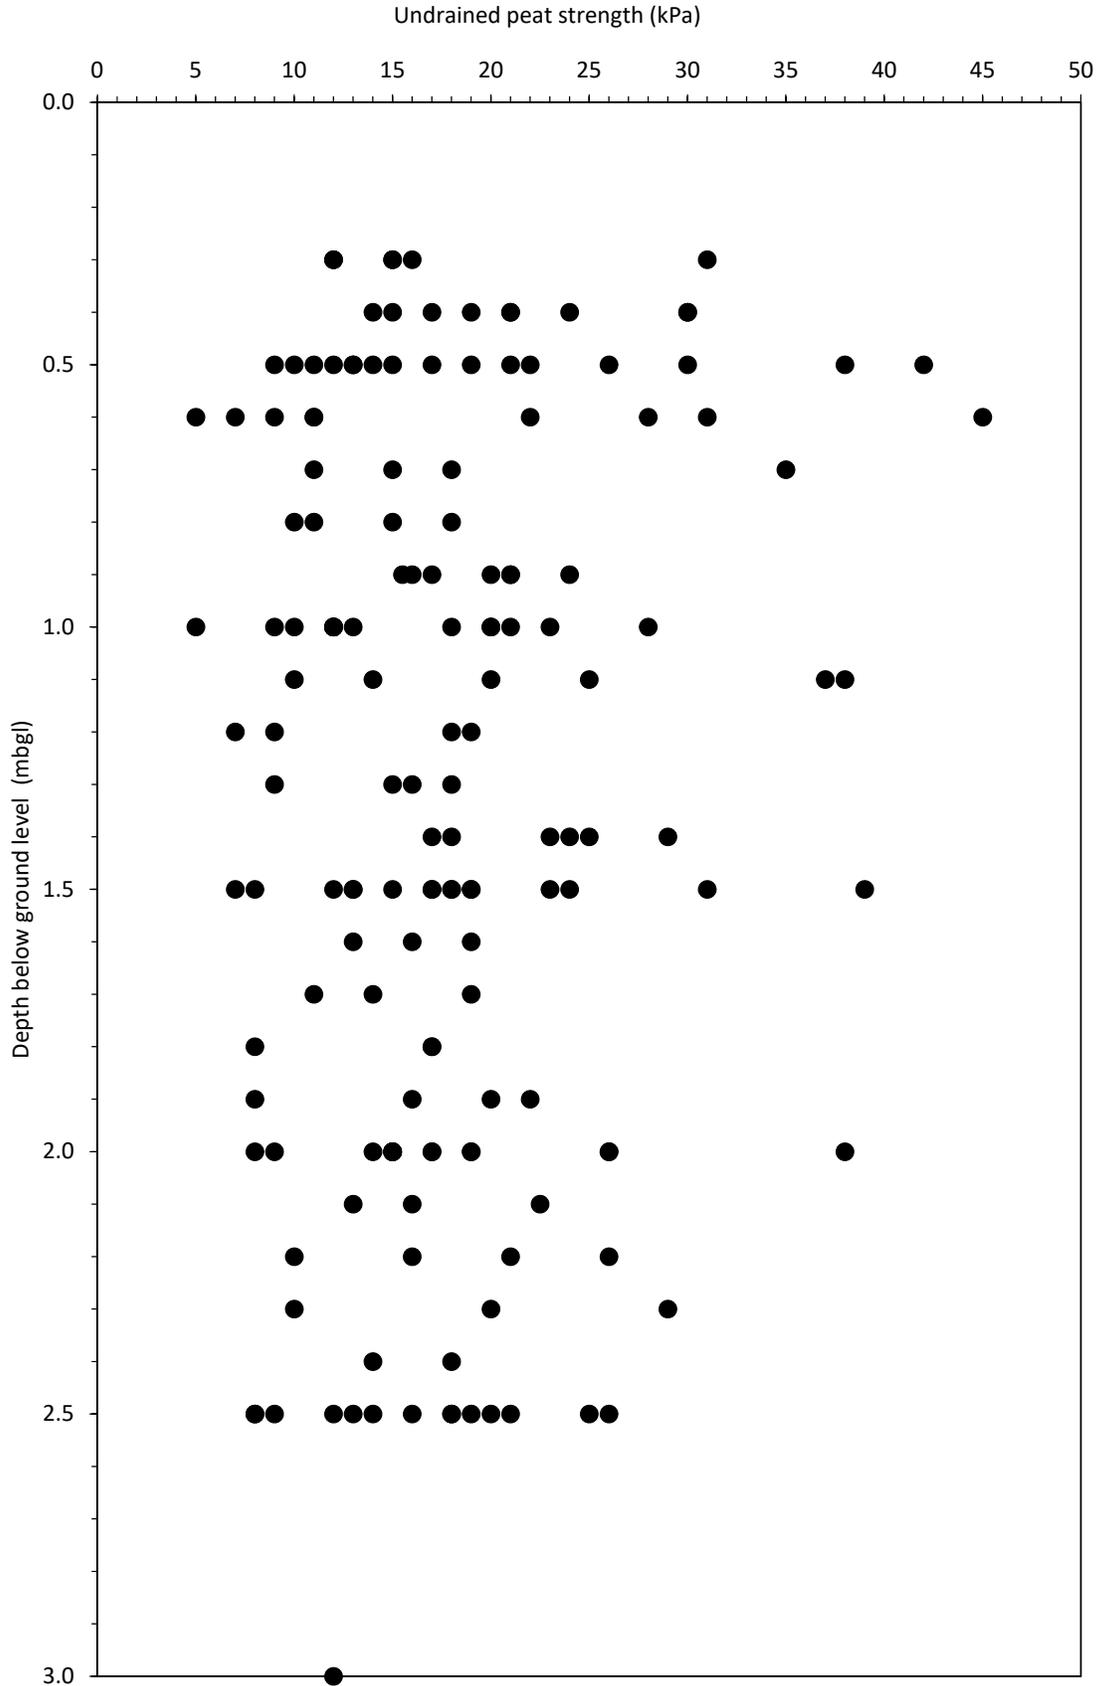
Figure 6-1: Undrained shear strength (C_u) profile for peat with depth

Peat strength at sites of known peat failures (assuming undrained loading failure) are generally very low, for example the undrained shear strength at the Derrybrien failure (AGEC, 2004) as derived from essentially back-analysis, though some testing was carried out, was estimated at 2.5kPa.

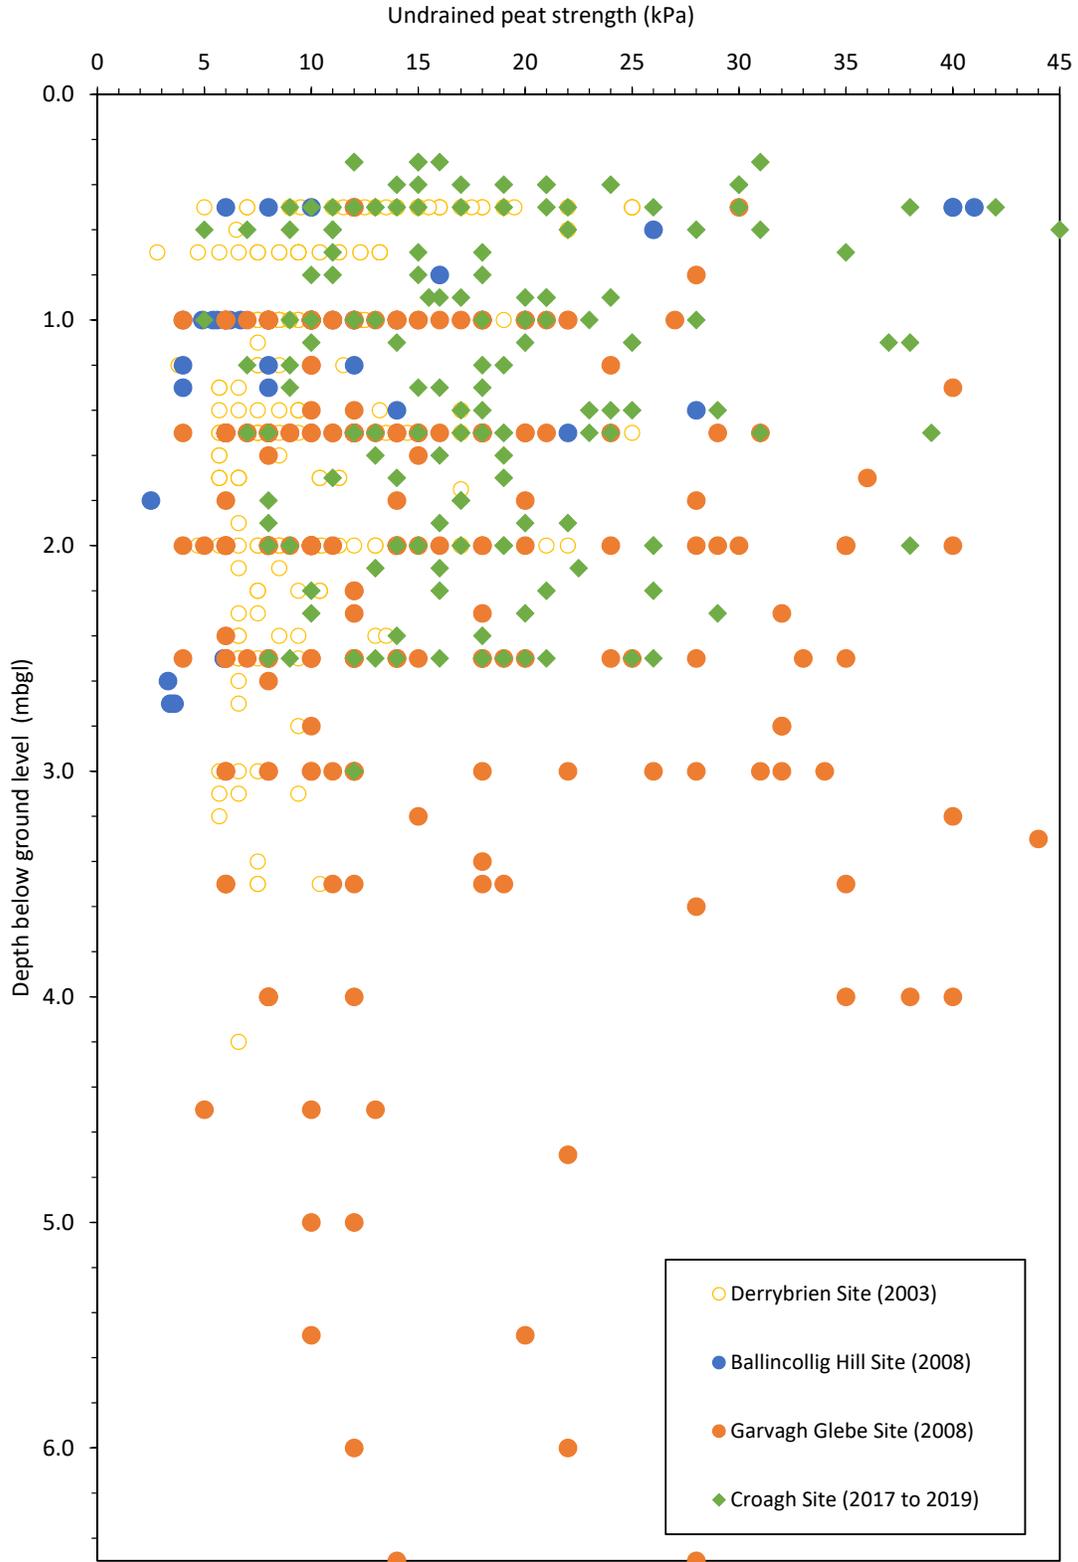
Figure 9-1: Comparison of peat strength (shear vane) with depth from other sites

- (1) Peat strength measured using a Geonor hand-head shear vane (H60).
- (2) Shear strength is unfactored.

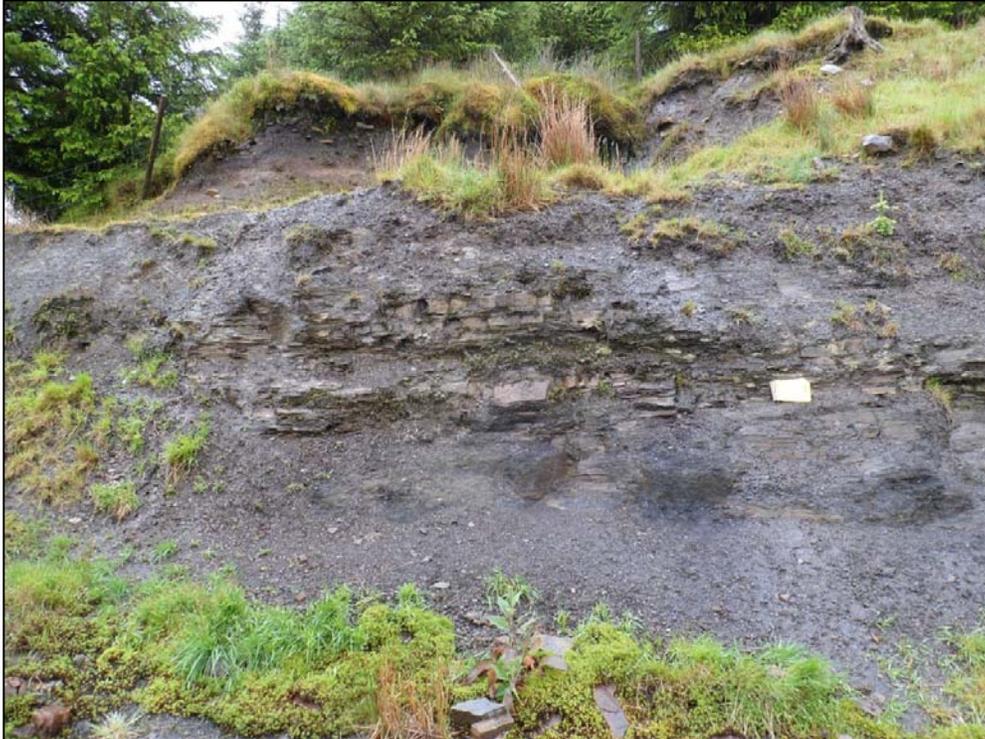
Photo 3 Example of ground profile at an existing excavation on site

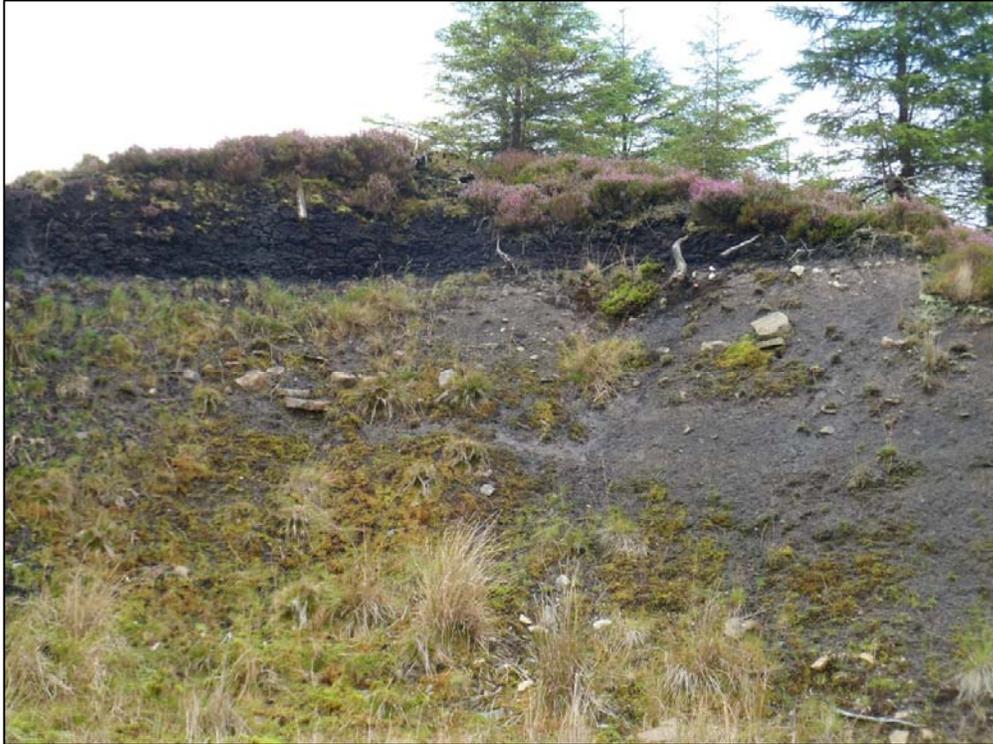
Photo 5 Example of ground conditions on site (peat overlying till)

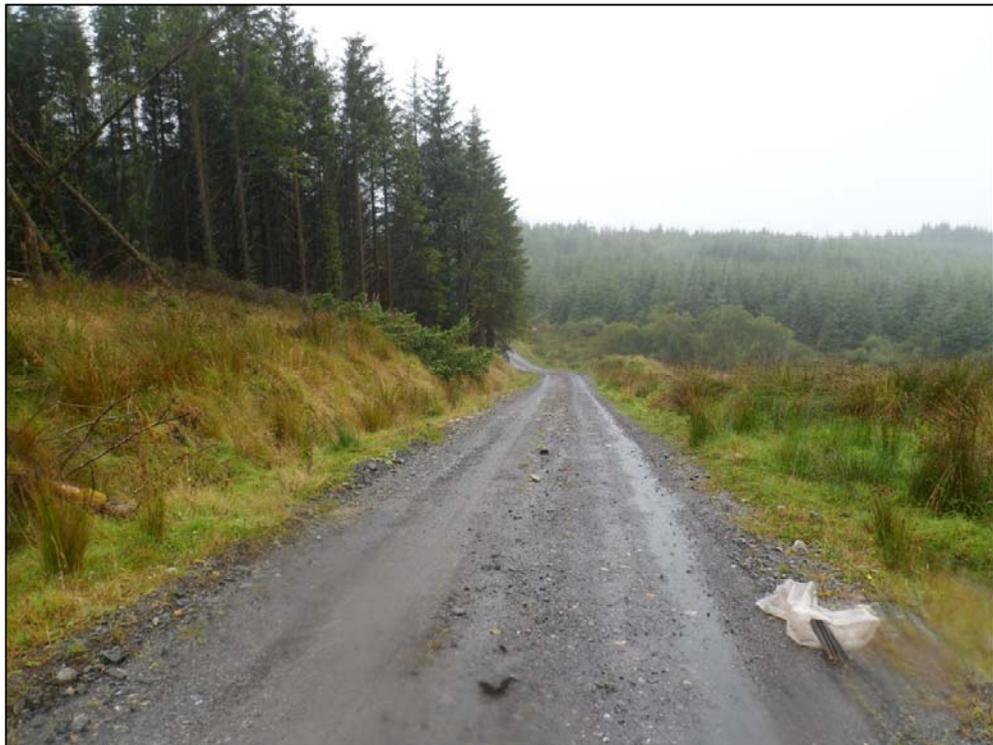
Photo 6 Example of founded access track on site

- (4) The access tracks for the wind farm will comprise upgrading of existing and construction of new tracks. The existing tracks were noted as being in relatively good condition and consist of both excavated/founded and floated tracks. An example of the existing tracks are shown in Photos 6 and 7.

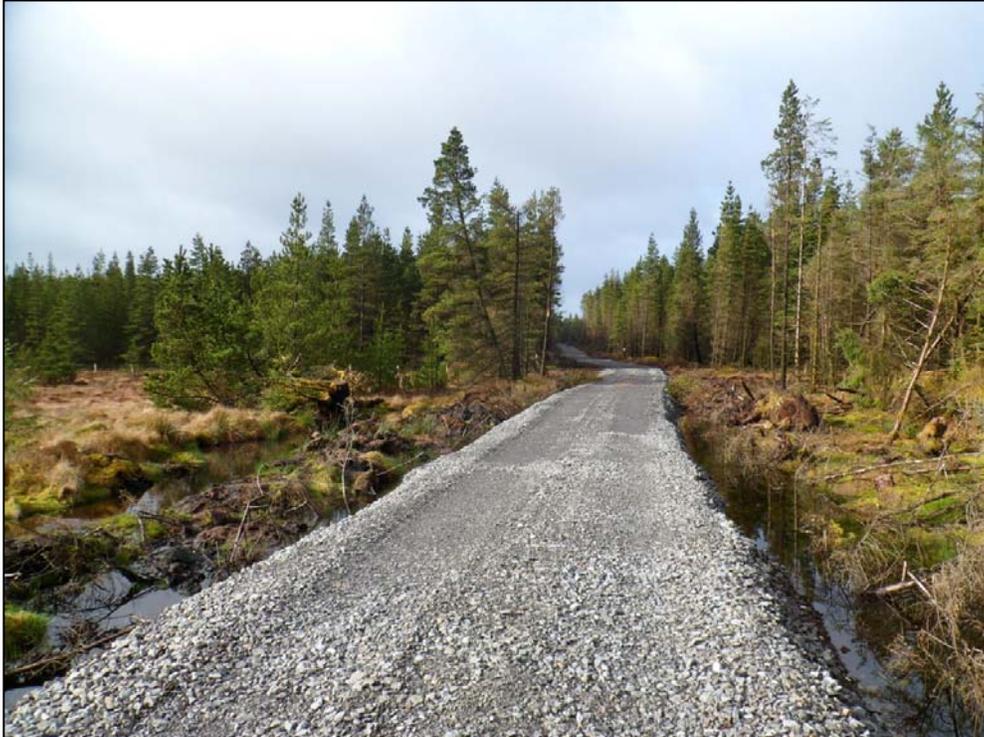
Photo 7 Example of floated access track on site

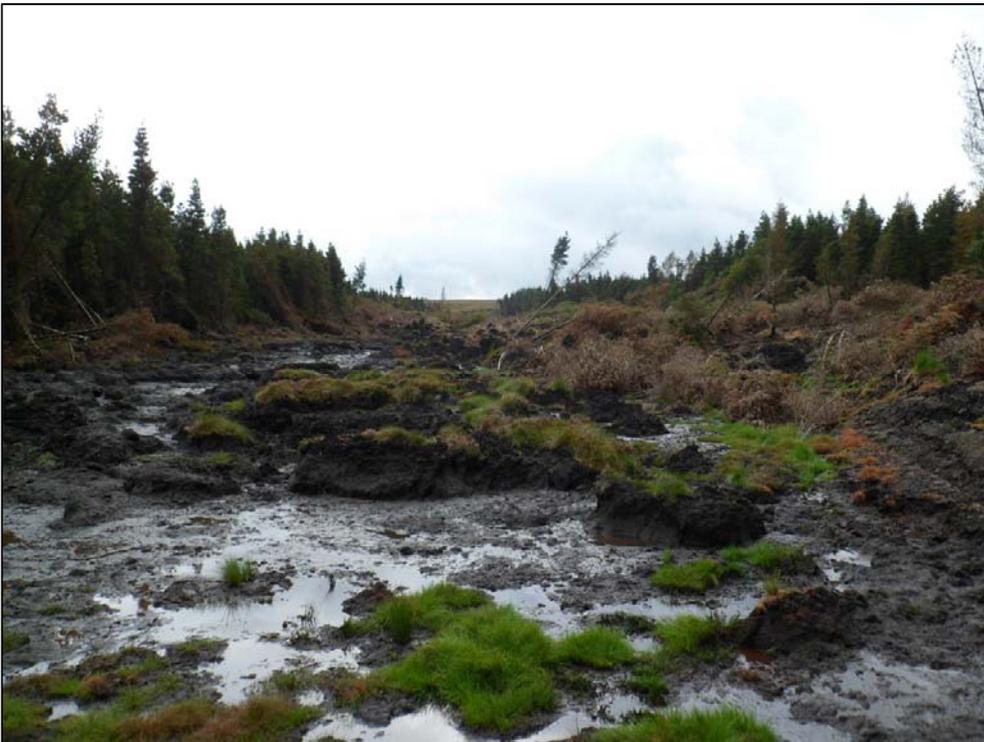
Photo 8 Overview of failure in the southwest of the site (looking south) – no development proposed for this area

- (4) Based on an inspection of the shear plane/failure surface, the failure is thought to have occurred within the silt/clay underlying the peat deposits. Photo 8 shows the failure surface.

- (7) The following combination of contributory factors to the peat slide are as follows:
 - (a) Peat cutting. 'Sausage' machine cutting was carried out within the source area of the failure. This cutting severs particularly the upper fibrous layer (acrotelm) reducing shear strength and allows ingress of surface water. The peat appears to have been cut in multiple directions.

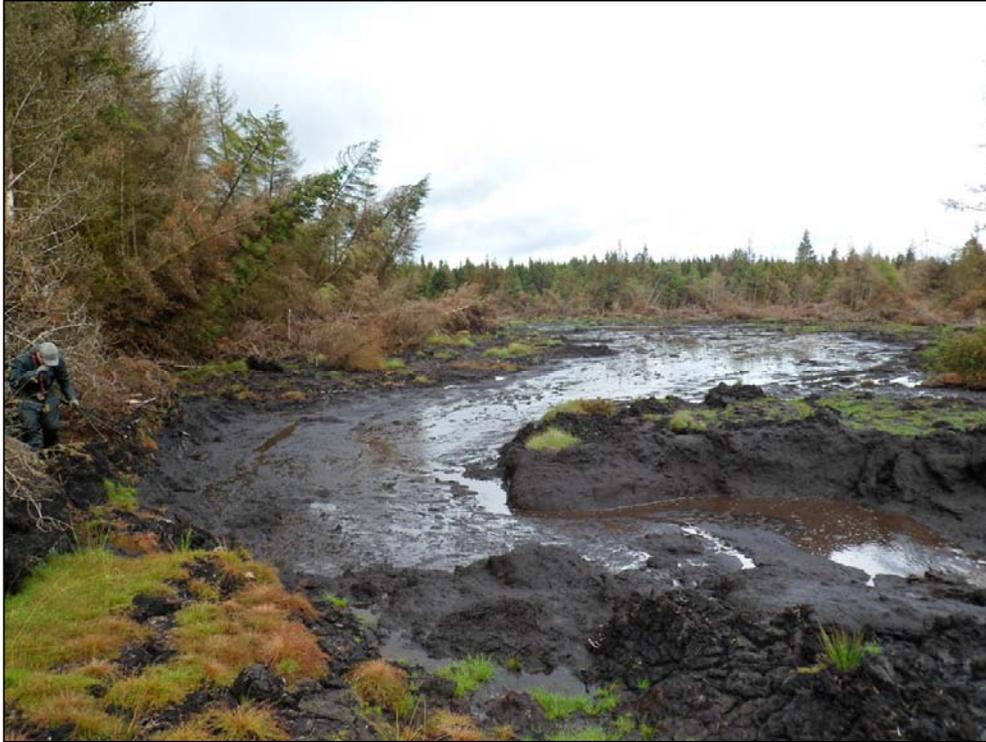
Photo 9 Overview of failure in the southwest of the site (looking north) – no development proposed for this area

- (9) A peat slide that occurred in 2016 on the surrounding plateau slopes of Croagh to the southwest of the site was inspected during the FT walkovers. An exclusion zone, where no development is recommended, around the landslide is shown on Figure 4-3. Section 4.2 of this report contains the main observations of the peat slide. In addition, see Photos 8 and 9 within Appendix A.

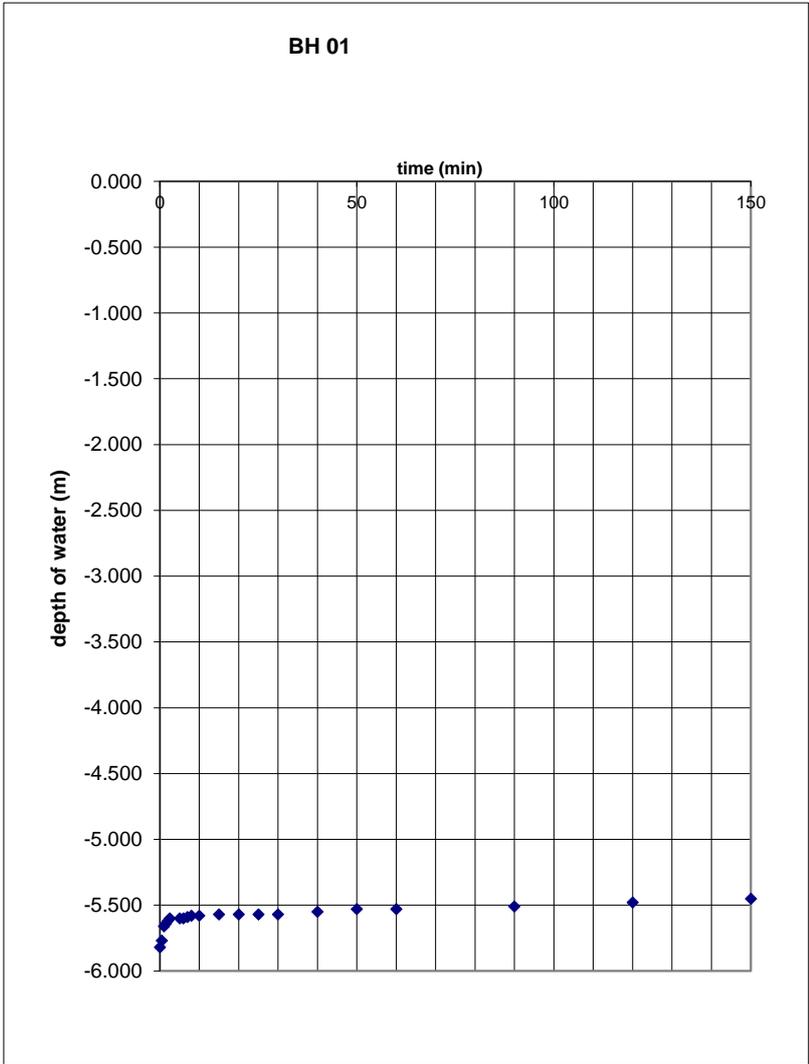
time min	WL m
0	-5.820
0.5	-5.770
1	-5.660
1.5	-5.640
2	-5.620
2.5	-5.600
5	-5.600
6	-5.600
7	-5.590
8	-5.580
10	-5.580
15	-5.570
20	-5.570
25	-5.570
30	-5.570
40	-5.550
50	-5.530
60	-5.530
90	-5.510
120	-5.480
150	-5.450

Remarks:
Water pumped out of borehole at commencement of test at rate of 0.25l per second.

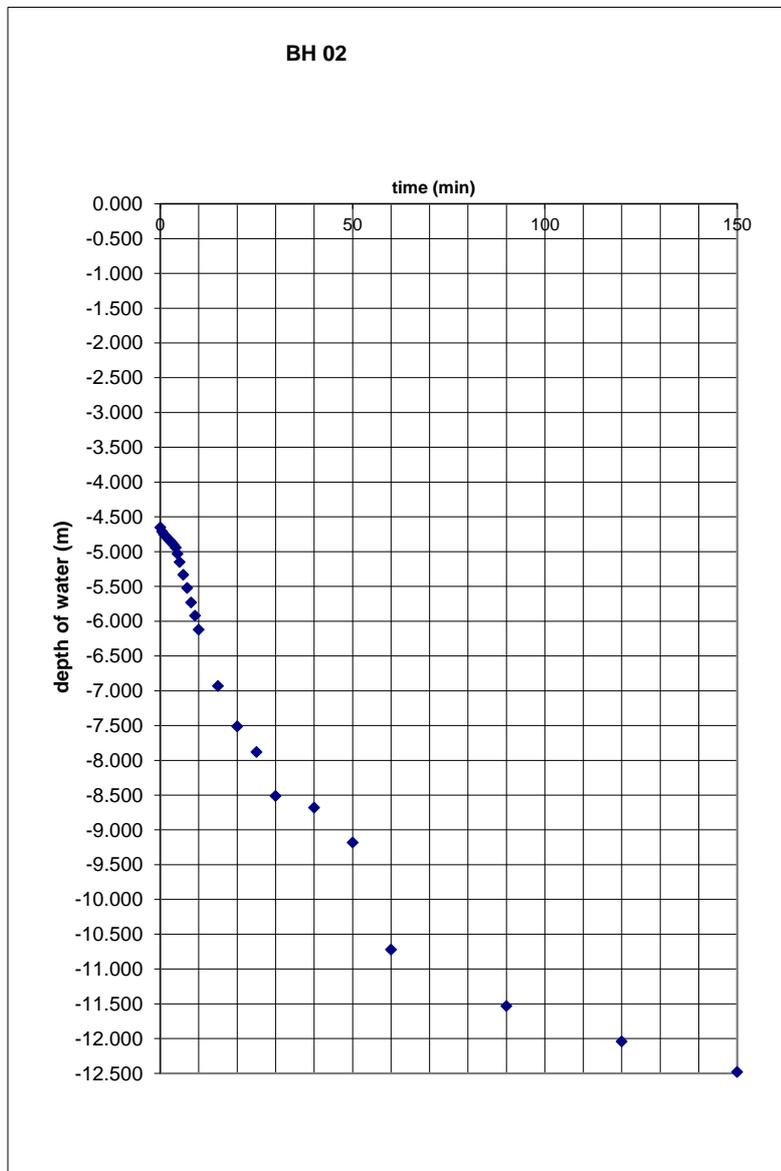
time min	WL m
0	-4.650
0.5	-4.710
1	-4.750
1.5	-4.780
2	-4.810
2.5	-4.840
3	-4.870
3.5	-4.900
4	-4.940
4.5	-5.030
5	-5.150
6	-5.330
7	-5.520
8	-5.730
9	-5.920
10	-6.120
15	-6.930
20	-7.510
25	-7.880
30	-8.510
40	-8.680
50	-9.180
60	-10.720
90	-11.530
120	-12.040
150	-12.480

Remarks:
50l of water added to borehole at commencement of test.
